1991 STUDY

1991 HAMILTON  
TRAFFIC OPERATIONS  
STUDY

CITY OF HAMILTON, MONTANA

MARVIN & ASSOCIATES

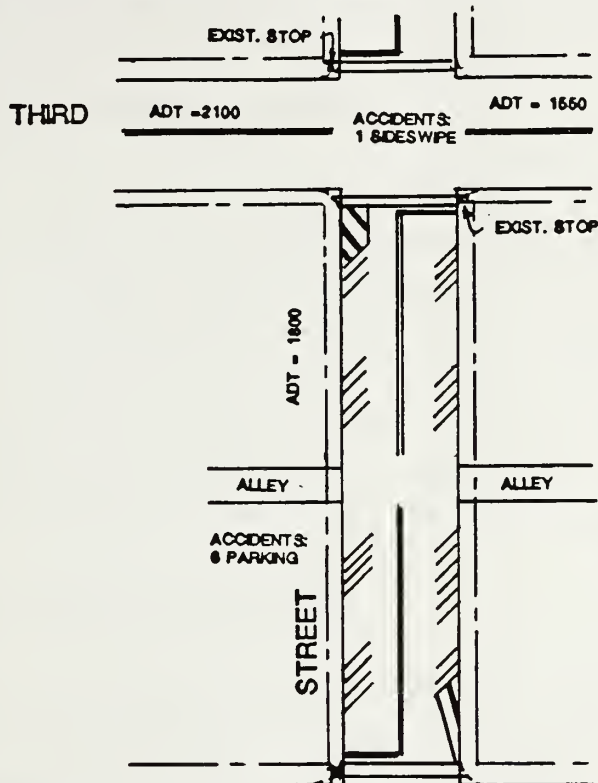
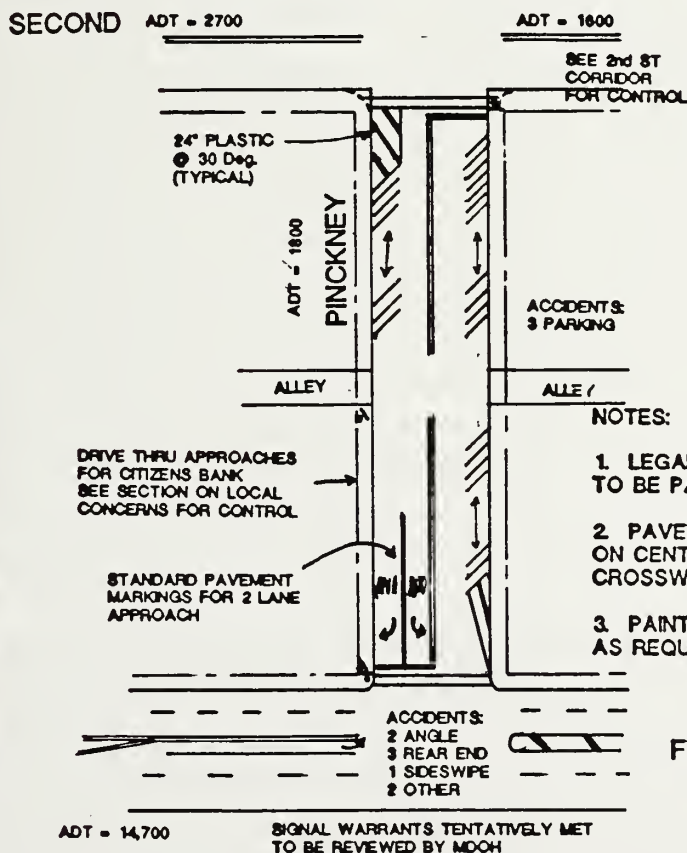
Accidents, other than those occurring at the bank access points and at the intersection with US 93, are primarily parking accidents or parking related accidents. As with other areas of the CBD, elimination of angle parking would be a prime recommendation. However, realistic continuation of angle parking must be considered. Figure VI-12, indicates the necessary work required to continue angle parking with increased safety. All parking restrictions at intersections and alleys must be marked and enforced. Centerline striping should be marked along with stop bars and cross walks, as shown.

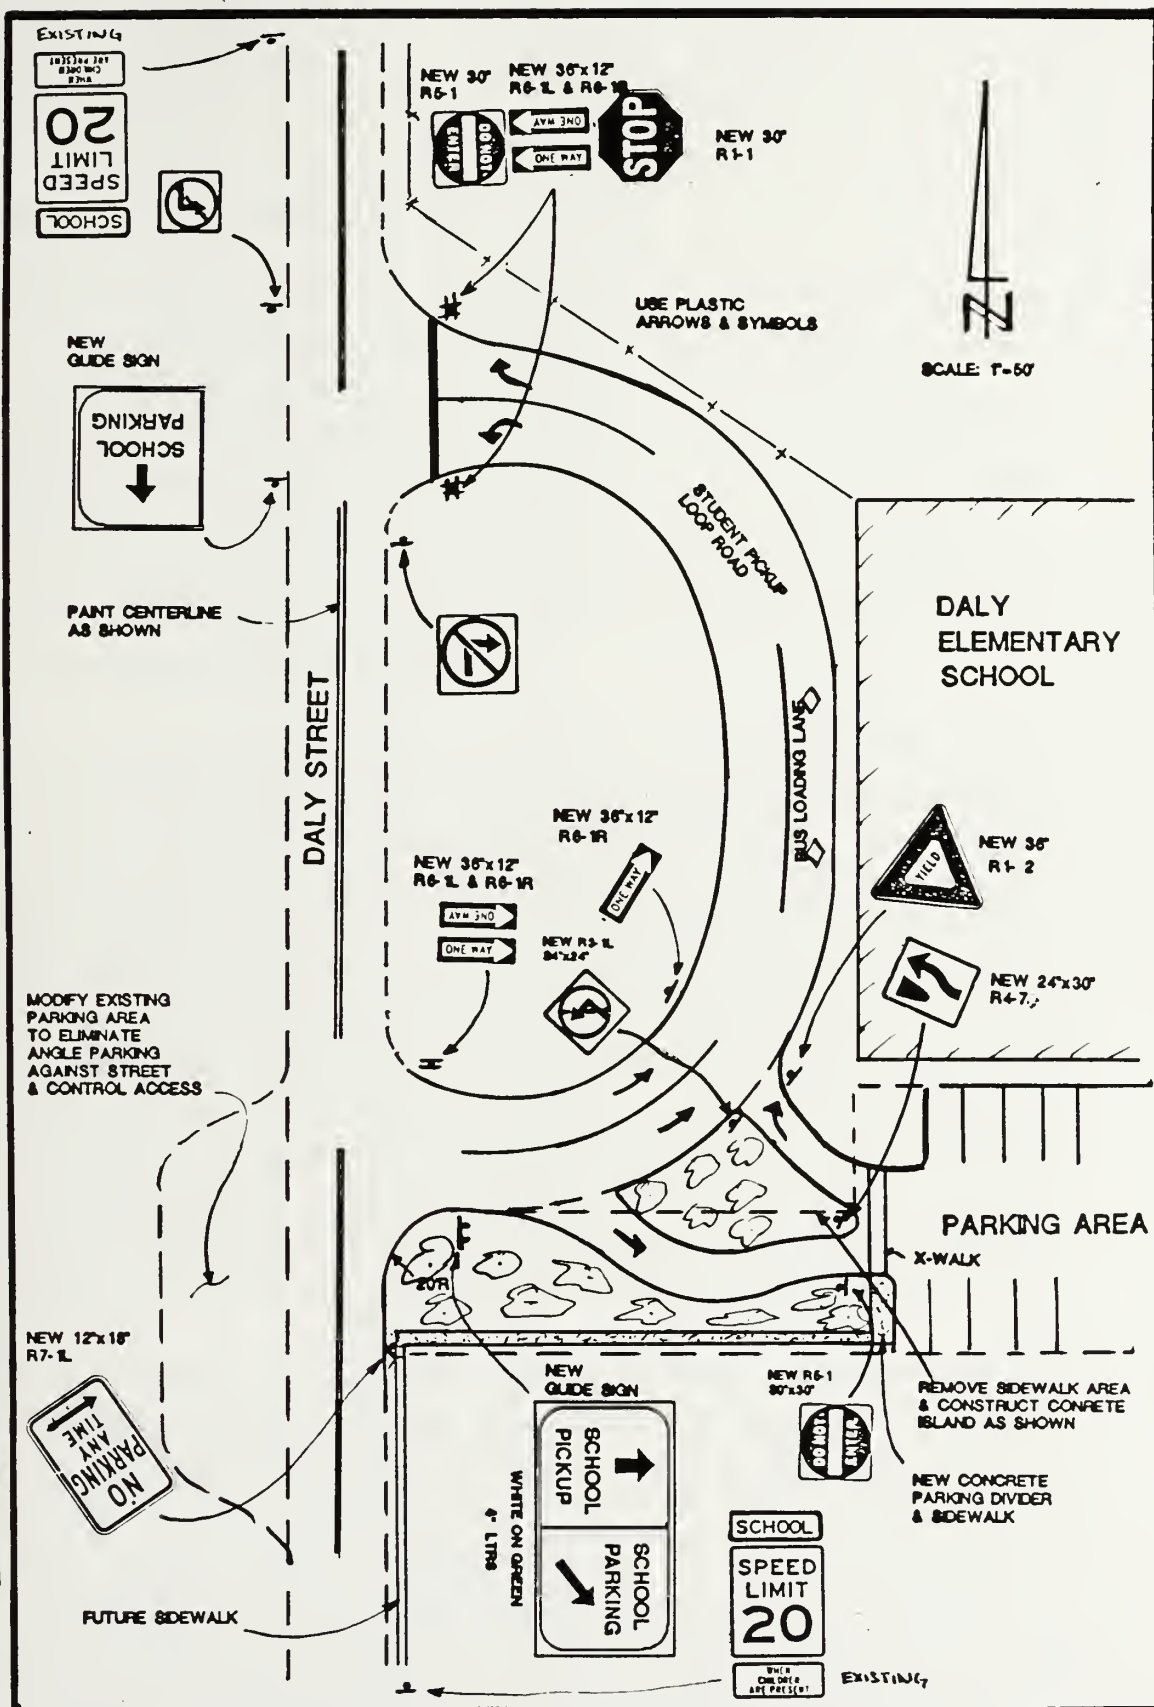
FIGURE NO.  
VI-17

Based on operational observations of the school crossings and traffic movements, recommendations for improvements would focus on controlling the blind approach at the south end of the property and constructing on-site pedestrian facilities. Figure VI-17. illustrates all of the proposed improvements at this site. In addition to on-site improvements, parking at the building, opposite the south approach, creates an unnecessary hazard to children, when vehicles back out of the perpendicular parking spaces into the street and in the path of children.

**TITLE: DALY SCHOOL AREA IMPROVEMENTS**

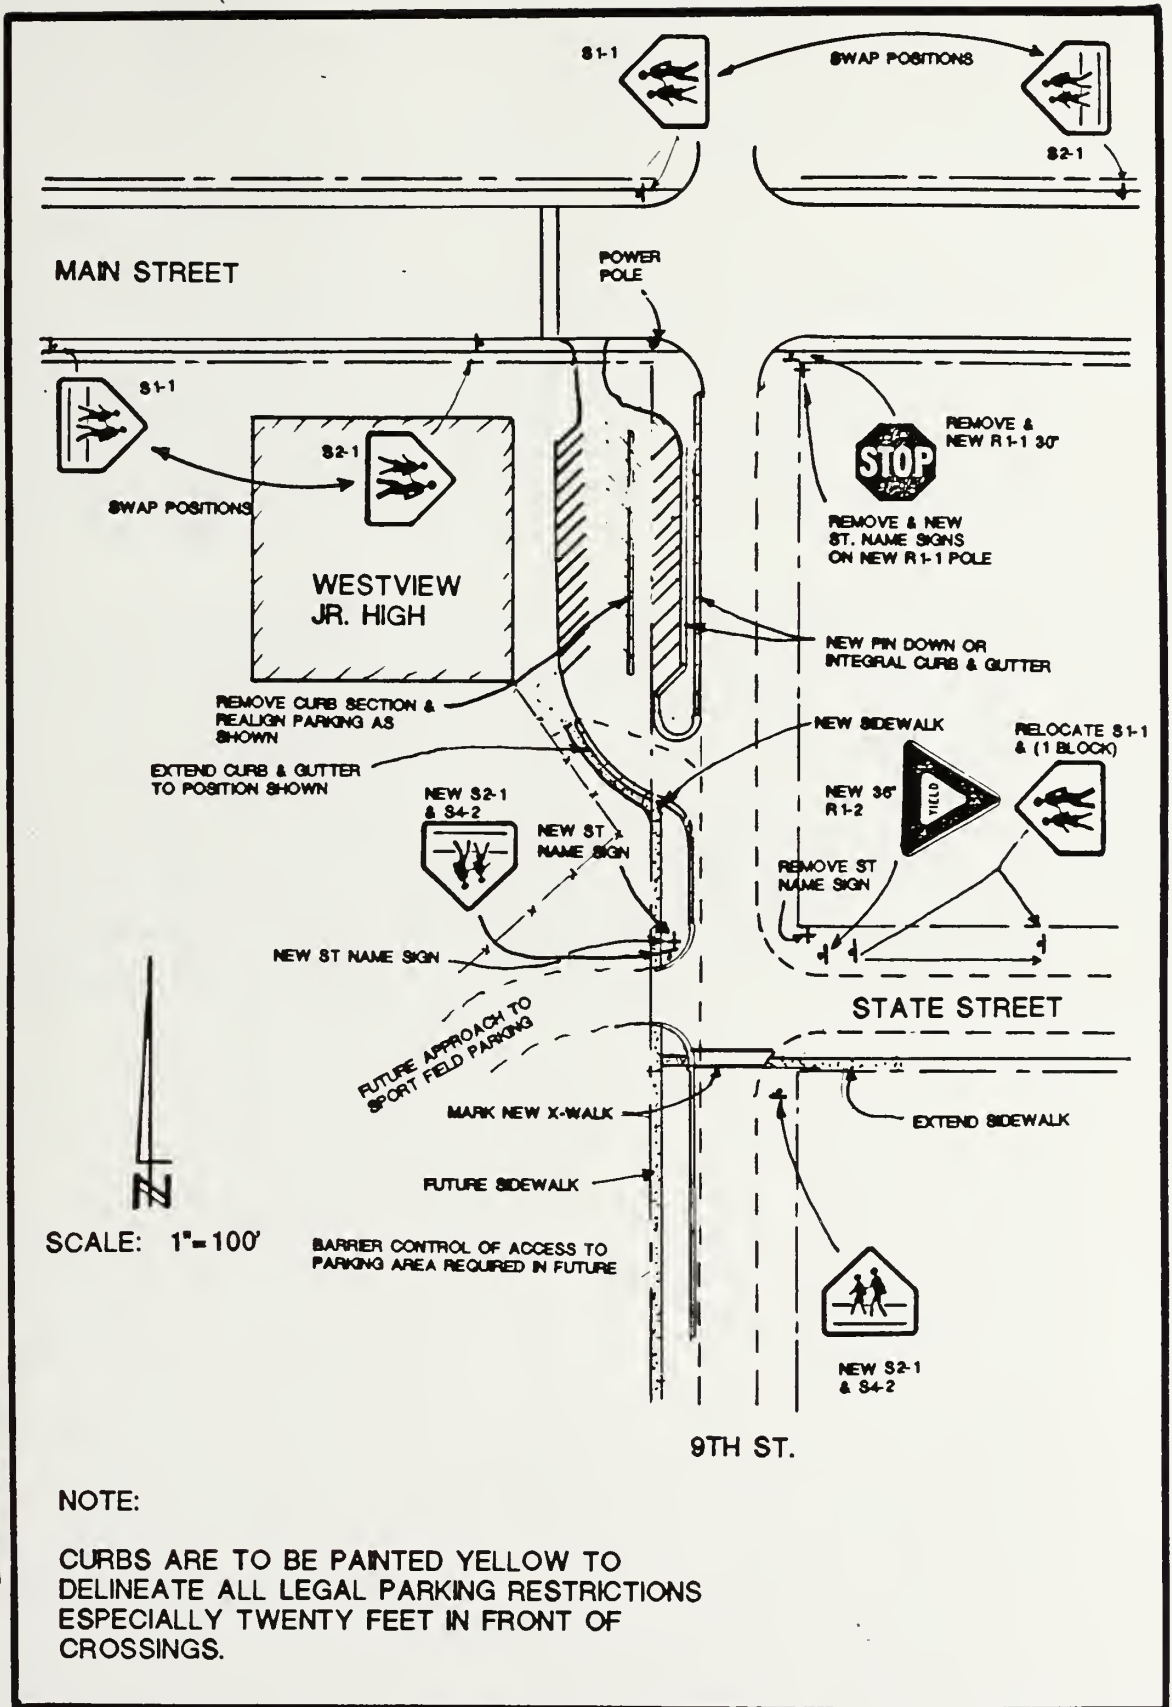
FIGURE NO.  
VI-18

There is an advanced school area sign on the State Avenue approach and school crossing signs on Main Street, on either side of the crossing, directly across from the school. It is noted that the advanced school warning signs and the school crossing signs on Main Street have been installed in reverse order. Speed studies on both Ninth Street and Main Street were taken during crossing periods. Data on those studies can be found in the technical appendix of this report. It was determined that the 85th percentile speed on Ninth was 26.7 mph and 30.4 mph on Main Street. Neither of these streets would warrant a reduction in the speed limit. There was very little pedestrian activity noted. Five children headed west on State Street and eleven pedestrian, including six adults, crossed at the Main Street crossing. Seventeen high school girls crossed ninth, at State, and proceeded to the sports field, for track practice. The only particular problems noted in this school area were related to improper parking control at the school and the lack of access control along ninth street.

TITLE: WESTVIEW JUNIOR HIGH  
SCHOOL AREA IMPROVEMENTS

Figure VI-18. illustrates the improvements at this site necessary to avoid potential vehicle and pedestrian conflicts and to insure controlled traffic operations. Future improvements should consider curb, gutter and sidewalk within this entire area.

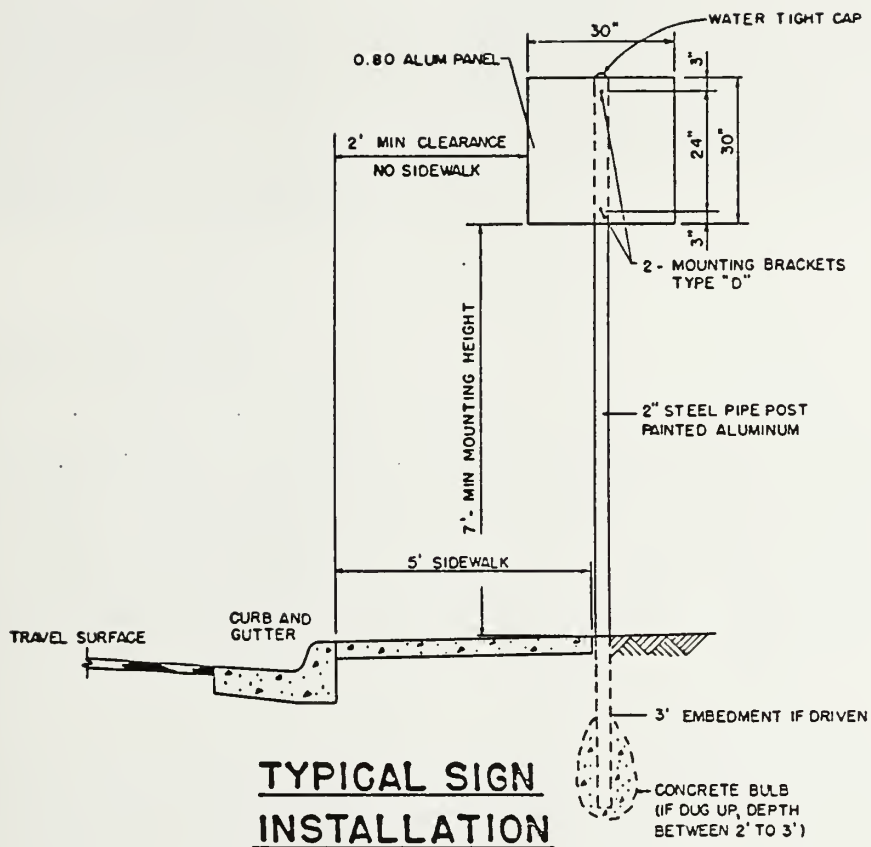
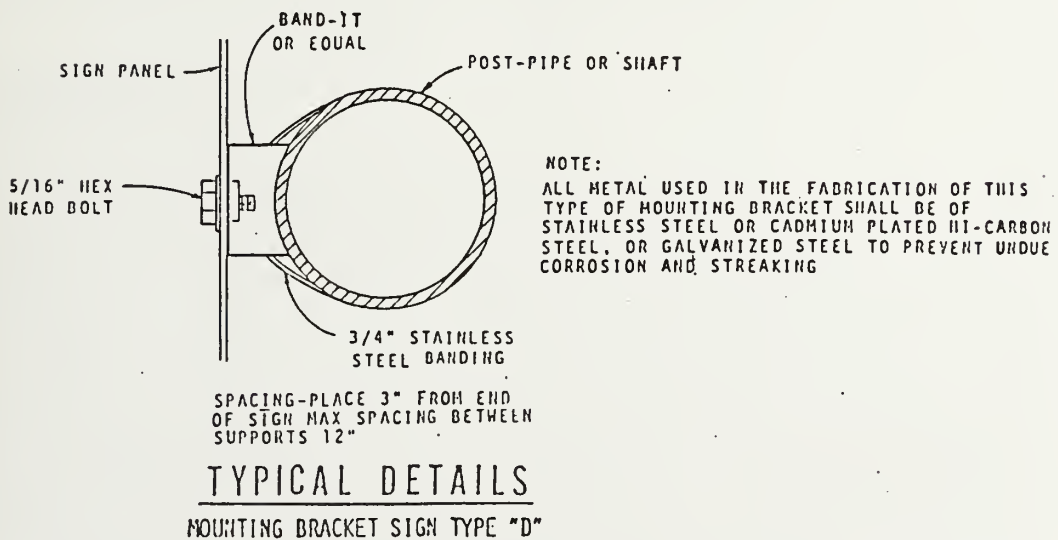
One of the most critical and common traffic devices in small communities, stop signs must be monitored periodically to insure effective usage. Approximately 50% of all stop signs in Hamilton were observed to have some degree of deficiency associated with them. Stop signs must be visible far in advance of the intended stop. The most common problem involving visibility, was linked to improper location or installation. The second most frequent problem was faded or damaged signs. Since signs lose reflectivity with time, all signs should be replaced after seven years, at least.

**FIGURE VII-1. TYPICAL SIGN INSTALLATION STANDARDS**

The most common stop sign size used in urban areas is 30"x30". In some circumstances, where accident problems have occurred or on wide streets and multi-lane facilities, it is advisable to replace these signs with 36"x36" or larger signs. When considering the aged driver population in Hamilton, it is recommended that all future stop sign replacements use a 36"x36" size, or larger.

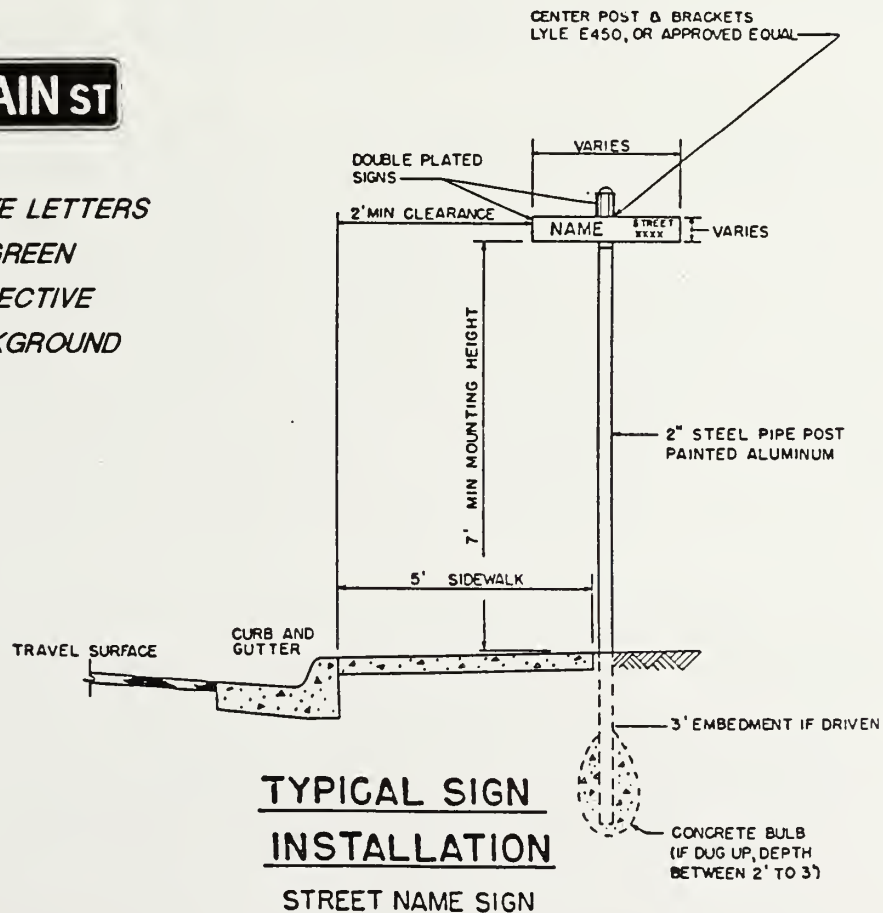
**FIGURE VII-2 STREET NAME SIGN GUIDELINES**

It is recommended that the City of Hamilton develop a program to replace all of the existing street name signs with new standard signs. If the program is to be completed over a period of years, it would be advisable to begin on the arterials and collectors and then start on the local streets. Figure VII-2 provides guidelines for sign types and installation, that can be adopted as standards, within the City.

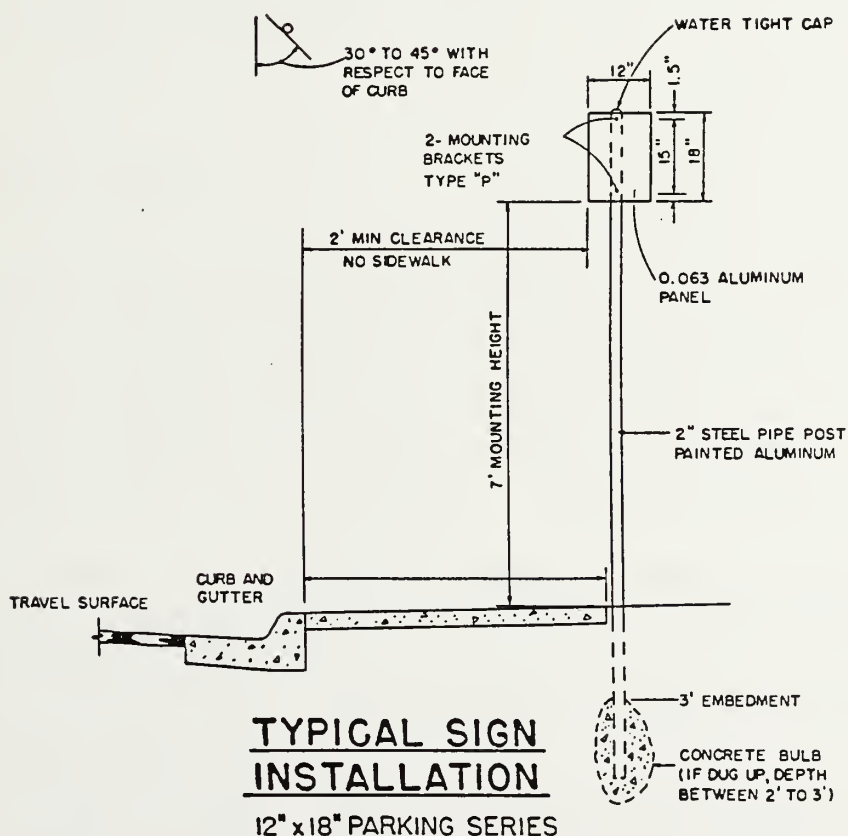
The most common regulatory signs in Hamilton are parking control signs. Problems noted in regard to the use of these signs, involve location and alignment. Within one side of a block in the downtown area, as many as five different parking regulation signs may be found with no consistent pattern. Circulating traffic has little opportunity to discriminate between open parking spaces. When the parking control sign is not clearly visible from the traffic lane, it can cause needless parking maneuvers.

FIGURE VII-3. TYPICAL PARKING SIGN DETAILS

Other parking control signs may be applied to specific spaces or locations or to an entire block. The exact placement and alignment of these signs is critical, to avoid confusion. Figure VII-3. illustrates the typical parking control signs found in MUTCD and provides a standard for installation of these signs. The R7-1 series of no parking signs are intended to marking the beginning and end of no parking zones with the use of arrows. The double headed arrow is an affirmation sign, usually placed at mid-block.

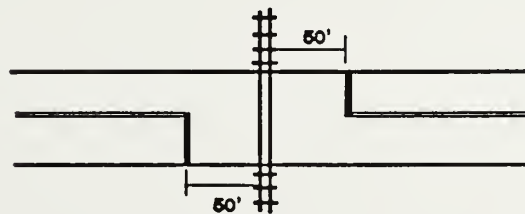
**FIGURE VII-4. PARKING RESTRICTION LOCATIONS**

Because of the apparent lack of knowledge regarding parking restrictions in Hamilton, it is recommended that the restrictions be published in the local paper and other media along with the Cities' intent to ticket illegally and improperly parked vehicles. This notice should be repeated several times over a period of weeks, prior to beginning an intensive enforcement effort. Periodic repetitions of this procedure should educate the majority of people in Hamilton and provide a safer traffic environment, within the City.
